Green Infrastructure & Stormwater Management CASE STUDY

Applebee's Support Center - Treatment Train

Location: Lenexa, KS

Design Firm(s): BNIM

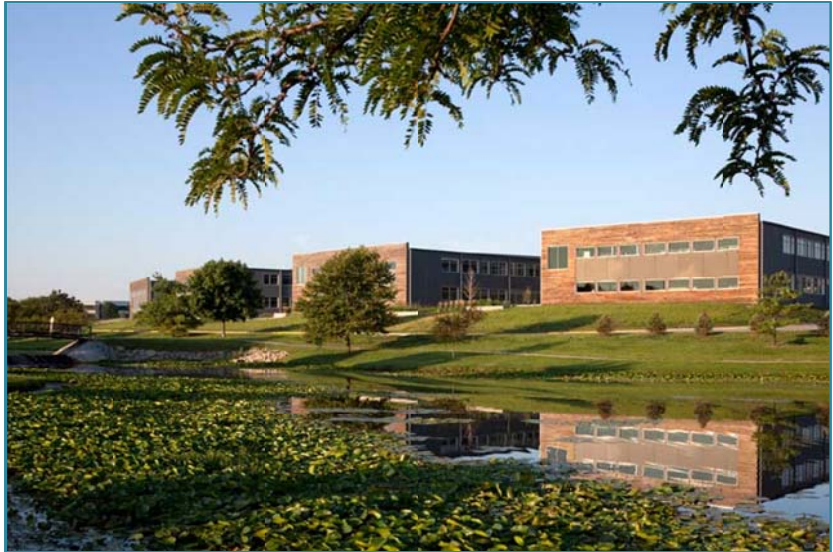
The restorative site design incorporates native landscape with water-efficient and low-maintenance prairie grasses, wildflowers, and storm water BMPs. Stormwater management is an integral part of the site design. All on-site stormwater, as well as a percentage of off-site water, is either absorbed or routed and cleaned within a treatment train of BMPs that include

native vegetated swales, rain gardens, rock sediment forebay, a sand filter, and a wetland prior to reaching the existing neighboring lakes. Each of the courtyards includes a series of rain gardens that treat roof runoff.

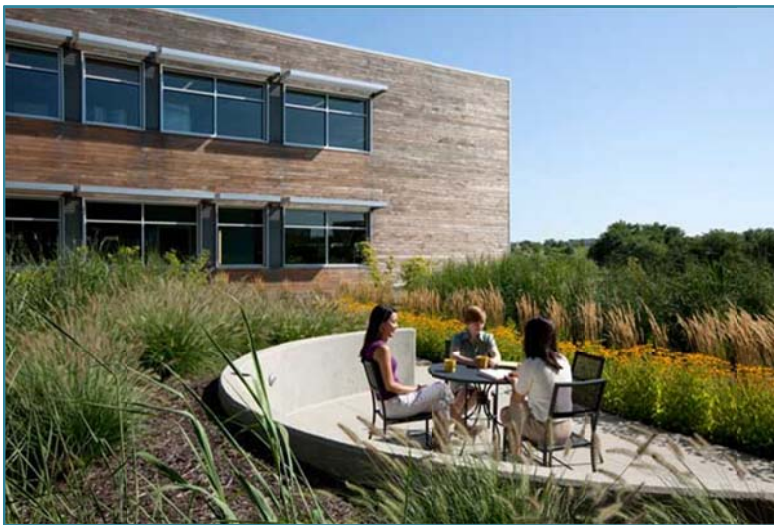
Design features: The design of the system includes a series of native plantings in sheet flow drainage areas, bioswales, rain gardens, bioretention areas, sediment forbays, a sand filter, and a wetland. These BMPs in linear configurations maximize pollutant removal for the parking areas and most of the site driveways.

It was anticipated that the quality of runoff after processing through the BMP Treatment Train would be substantially cleaner than the runoff from the adjacent public street (or traditional street/parking lot design). Compare the LEED documents submitted for the LEED Silver Certification application to the actual finding observed and prove the appropriate complete stormwater credits were met.
