Green Infrastructure & Stormwater Management CASE STUDY

Waterview Recreation Center

Location: 5826 McMahon St., Philadelphia, PA

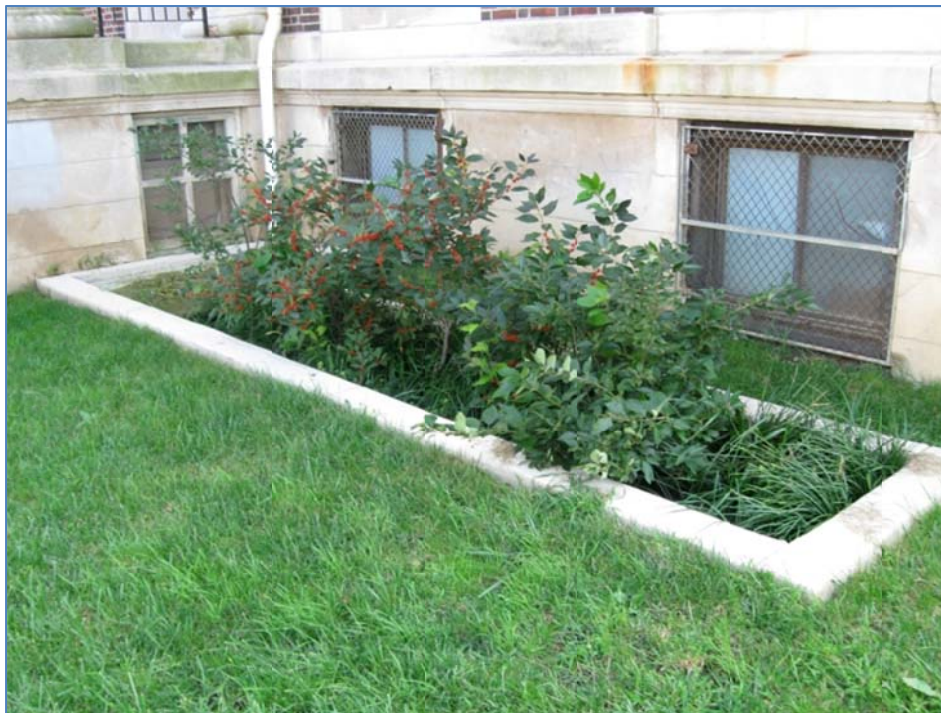
Image: Philadelphia Water Department

Project Description: This site serves as a demonstration for several types of green infrastructure. The sidewalk in front was replaced with porous concrete, a first for any sidewalk in Philadelphia. Stormwater infiltrates into a stone trench that also collects runoff from the street and waters trees behind the sidewalk. Roof leaders have been disconnected and connected to flow-through planter boxes.
